**CWA OVERSIGHT INSPECTION REPORT**

## "Rockford Region Agricultural Field Investigation Report"

**File:** Scheidairy Farms, Inc.  
**County:** Stephenson  
**Date:** May 24, 2011 9:45 AM - 1:25 PM  
**Address:** 1730 W. Buckeye Road  
Freeport, IL 61032

SCHEIDAIRY FARMS – 1730 W Buckeye Rd, Freeport IL – 5/24/2011 Inspection

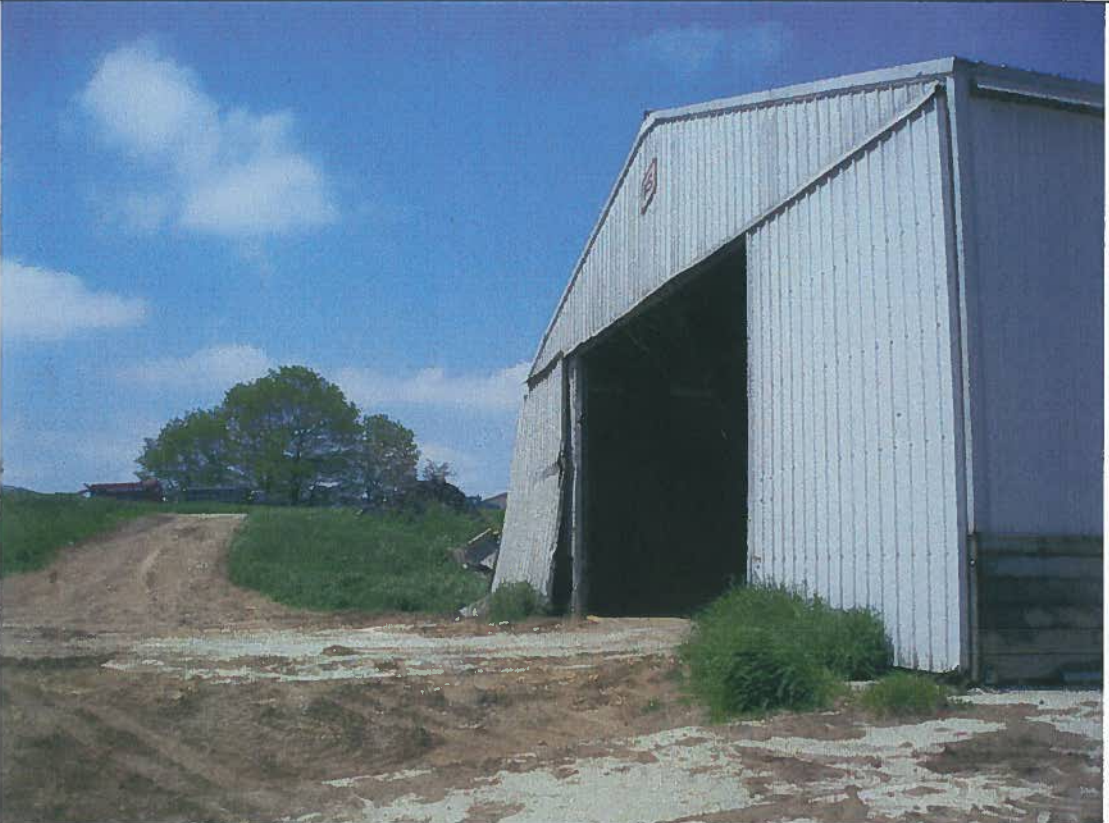
<b>County:</b> Stephenson	
<b>Comments:</b> View of the commodity storage shed. Runoff from silage pads will flow via gravel drive toward view point and then to the holding pond. View is northwest.	
<b>Photo #:</b> 31	
<b>Photo Title:</b> 052411_ ScheidairyFarms_KWB(43)

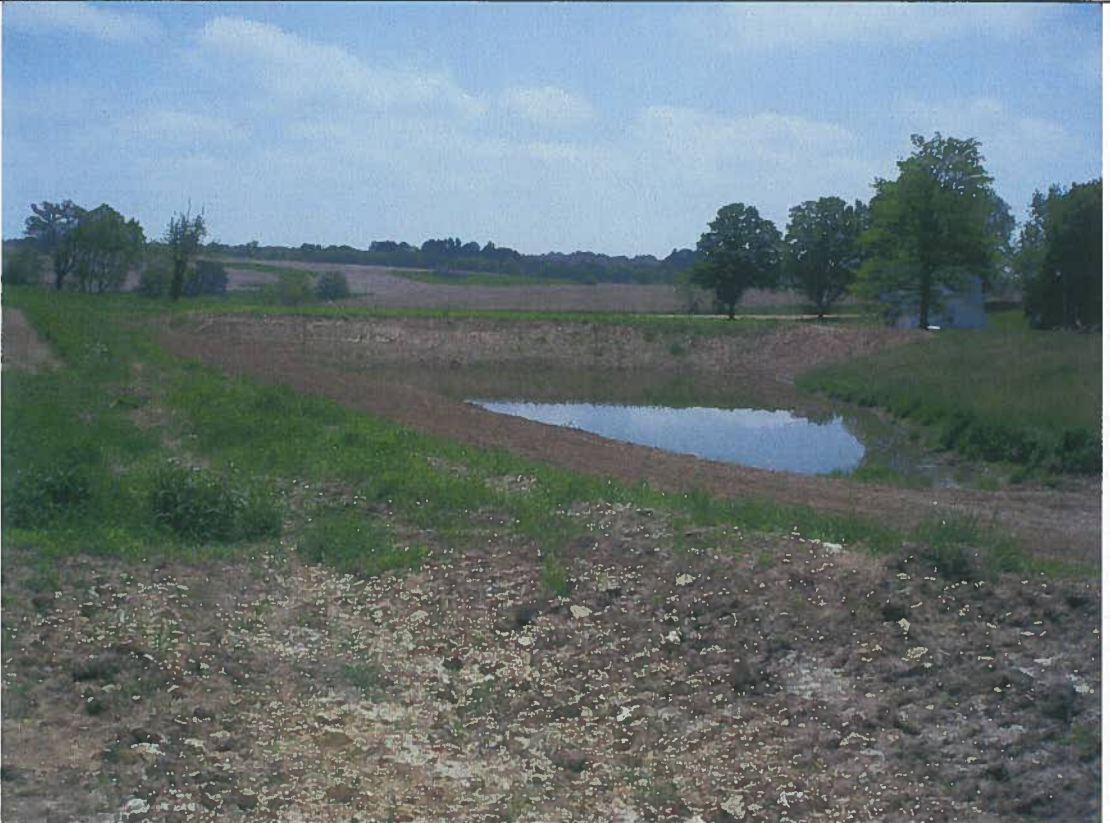
<b>County:</b> Stephenson	
<b>Comments:</b> View of the waste holding pond. Clean water diversion is to left. Freeboard marker is visible at left of pond. West Buckeye Road is visible behind berm. View is south.	
<b>Photo #:</b> 33	
<b>Photo Title:</b> 052411_ ScheidairyFarms_KWB(45)
